## **Sounds as an expression of urban vitality: changes in the neighborhood's soundscape affected by technological disaster in Maceió - AL, Brazil**

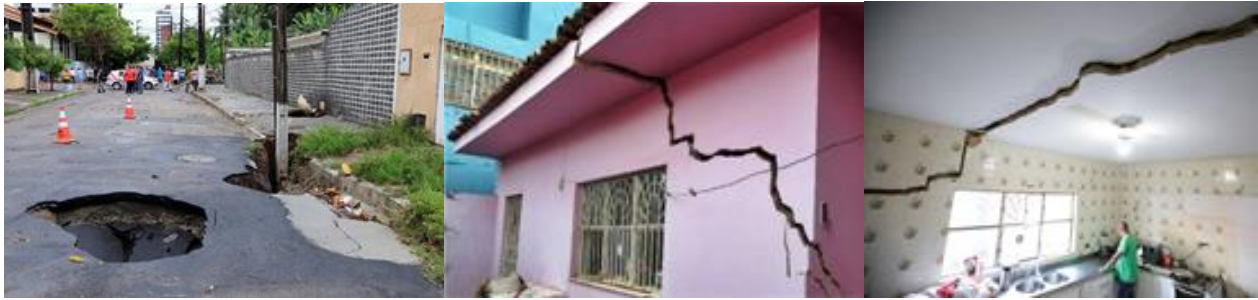
The first signs of soil subsidence occurred in February 2018, after a rainy period in the city. Seismic tremors caused structural collapse of streets and buildings, and quakes of 2.4 on the Richter scale were recorded, causing craters in the roads and cracks in the walls of buildings (Figures 2, 3 and 4). In December 2018, an emergency situation recognized by the Brazilian Federal Government was decreed, from which families had to leave their homes and received a social rent aid paid by the federal government. The damage caused to the soil was aggravated by the installation of extraction wells in places with pre-existing geological faults in the region, which caused loss in the structural integrity of the rock salt exploration caves and consequent collapse.

Figure 2, 3 and 4: Craters in the streets and cracks in buildings caused by earth moving. in the Pinheiro district. Source: Freitas (2019) [5].

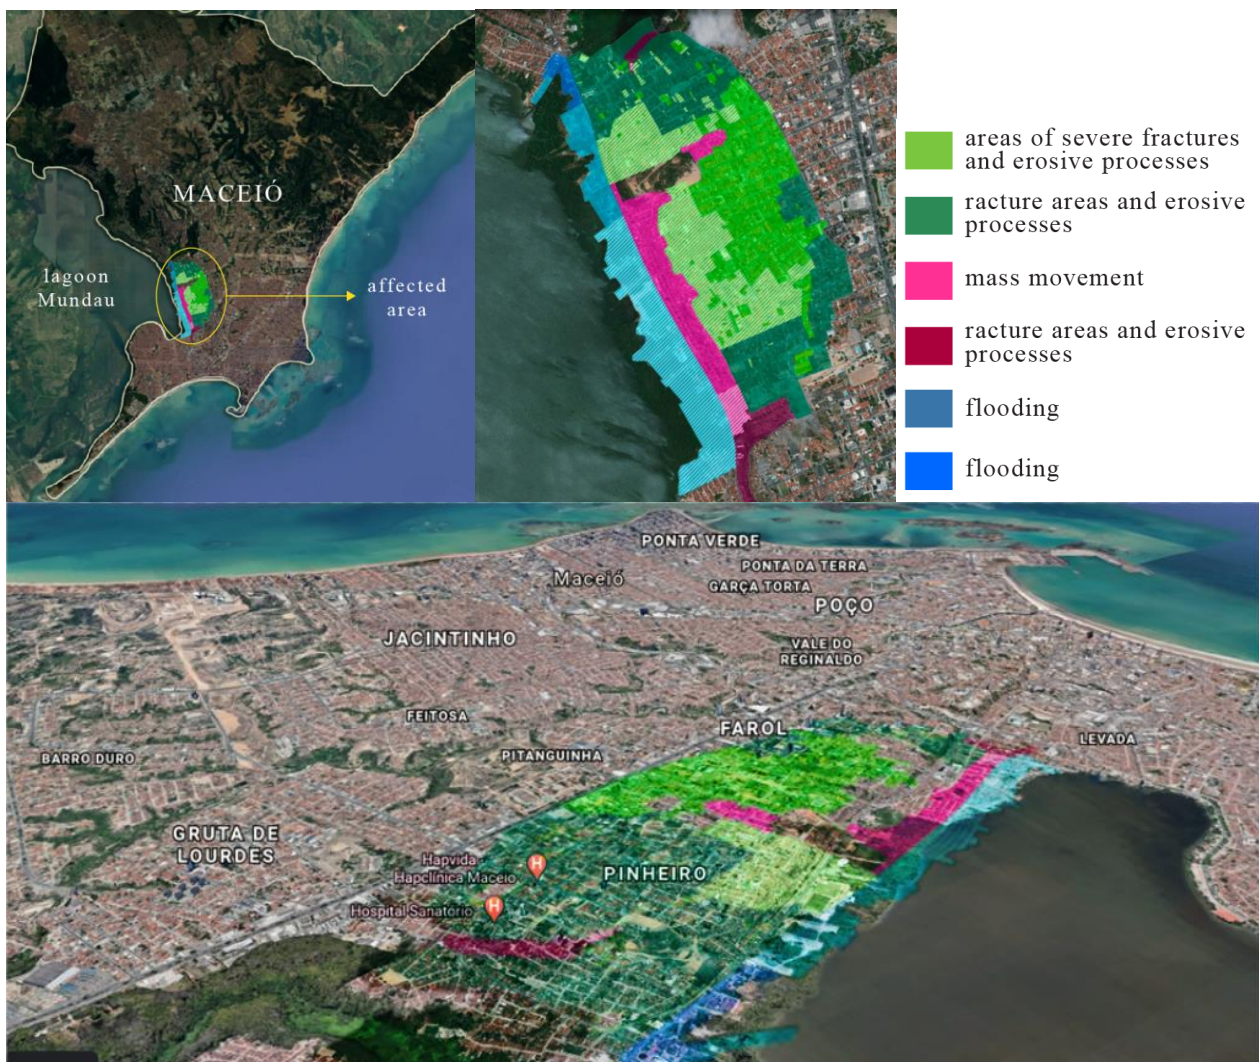
The Municipal Government did a mapping of the damage caused to the region. Initially, only the neighborhood of Pinheiro was in the critical zone, after deepening the studies, the area expanded contemplating the neighborhood of Mutange and part of the neighborhood of Bebedouro. Areas with more severe fractures and erosion were classified, areas with erosion processes, land movement areas (steeper areas), and flooding areas (areas bordering the Mundaú Lagoon) (Figure 5).

Figure 5: Demarcation of the area affected by the technological disaster. Source: Google Earth, 2020. Adapted by the authors, 2020.

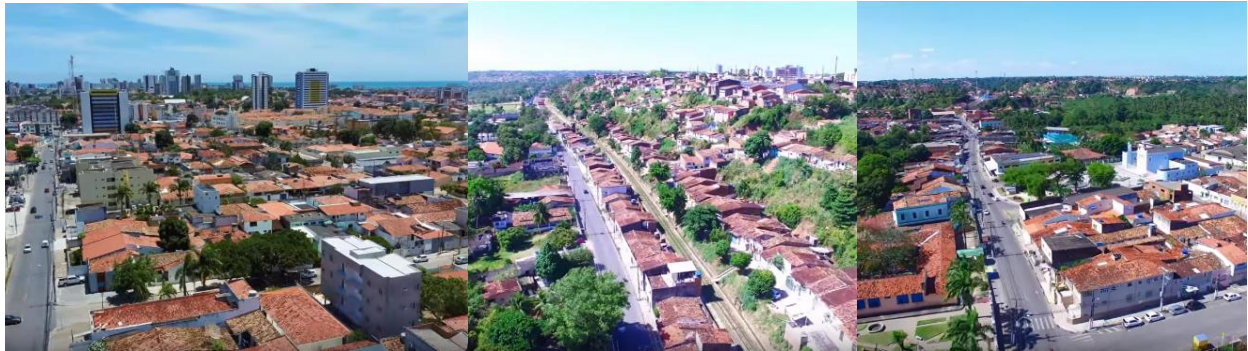
*Figures 6, 7 and 8: Aerial view and urban forms of the neighborhoods Mutange, Bebedouro and Pinheiro, respectively. Source: PJM Drone, 2019. Available at: <<https://www.youtube.com/channel/UC5XypoND3jHZbpD0e-OUd7g>> .*

The technological disaster brought serious consequences to the three neighborhoods, the fact generated rupture in social relations and local urban dynamics. The neighborhoods had high demographic density and were connectors from the upper to lower part of the city. The current scenario is one of destruction, abandonment and neglect with the residents' sense of belonging (Figures 6, 7, 8, 9, 10 and 11).

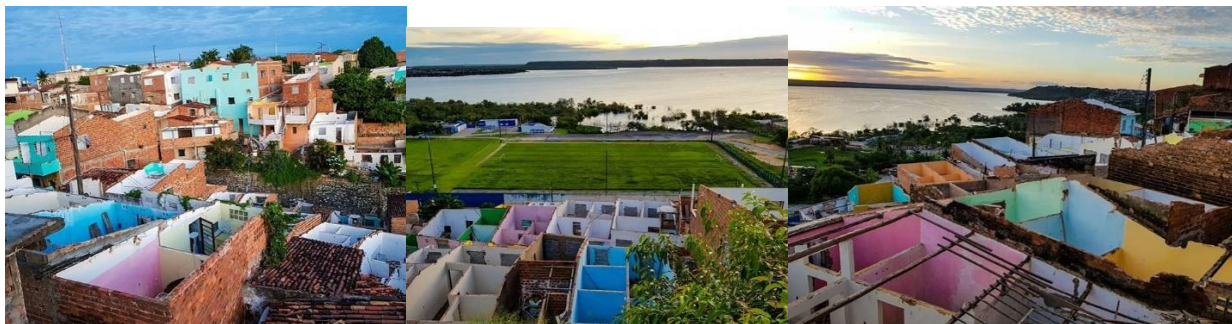
*Figures 9, 10 and 11: Photos of the Mutange, Bebedouro and Pinheiro neighborhoods after the area was emptied. Source: Maceió former officer. Available at: <https://www.instagram.com/p/B-8JD25J0rY/>.*

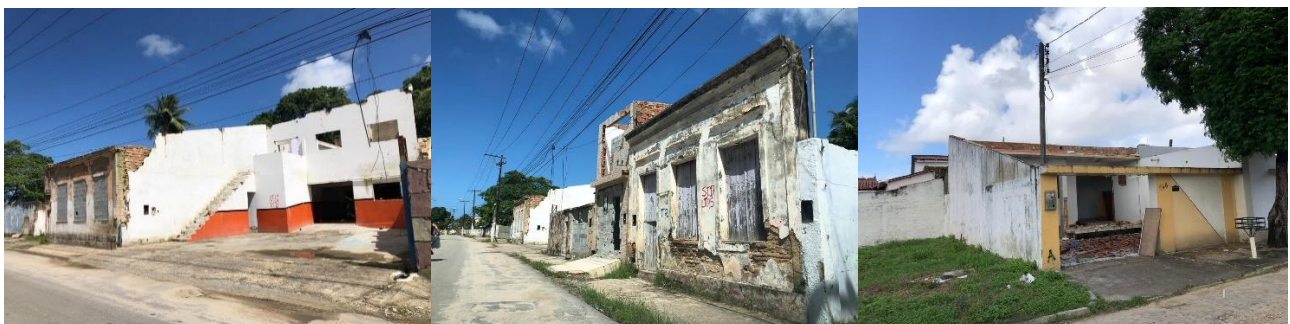
The abandonment is evident, most of the buildings in the neighborhoods are unoccupied and deteriorated, with no elements of fence such as roofing, frames (Figures 12, 13 and 14). The inhabitants of the area are signaled by means of signs about their permanence in the neighborhoods. (Figures 15, 16 and 17).

*Figures 12, 13 and 14: Abandoned and dilapidated buildings in the affected neighbourhoods.*

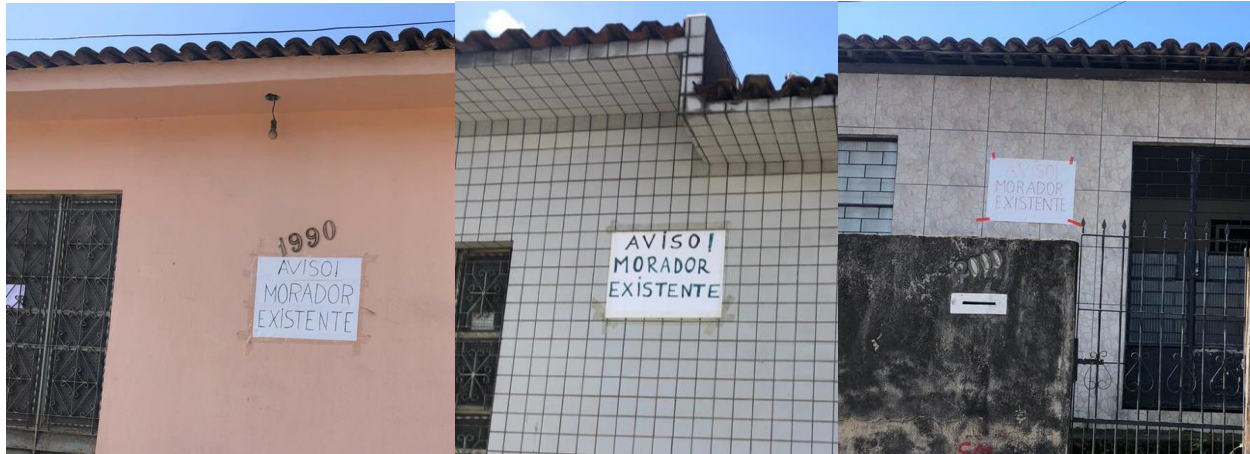
*Figures 15, 16 and 17: Notice signalling the existence of local residents.*

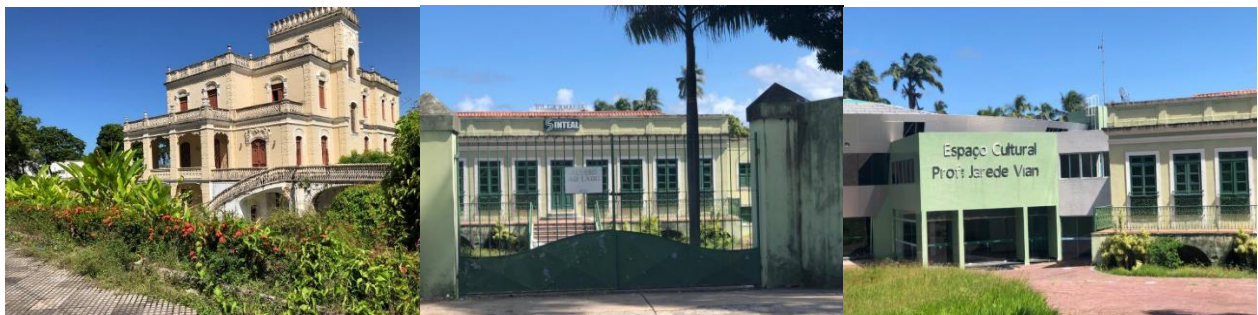
*Figures 18, 19 and 20: Abandoned historical buildings of cultural importance.*

The Mutange and Bebedouro neighborhoods have representative historical buildings for the city of Maceió, which are currently abandoned and exposed to deterioration. Figures 18, 19 and 20 present, respectively, a historical building, where the Dr. José Lopes health care home, the headquarters of Sintear (Union of Workers of Alagoas) and the cultural space Professora Jarede Viana, besides the headquarters of the Environment Institute (IMA), all closed.

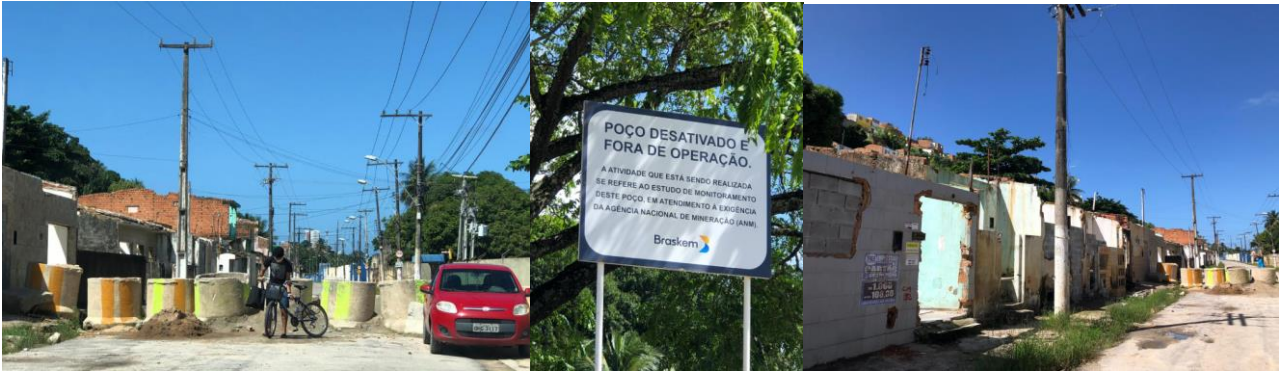
A decrease in the SPL values measured after emptying the area is noticed, which confirms the hypothesis that the lack of urban vitality directly interferes with the sound environment. This is even more evidenced, with the observation of the decrease of vehicles circulating in the area. Parts of the affected region are interdicted, some roads were deactivated. Recovery services of the damages caused in the area generate noise from mechanical equipment resulting from these activities. For example, the well monitoring study, conducted in compliance with the requirement of the National Mining Agency (Figures 21, 22 and 23).

*Figures 21, 22 and 23: Existing barrier in front of Braskem, there is no car passage.*

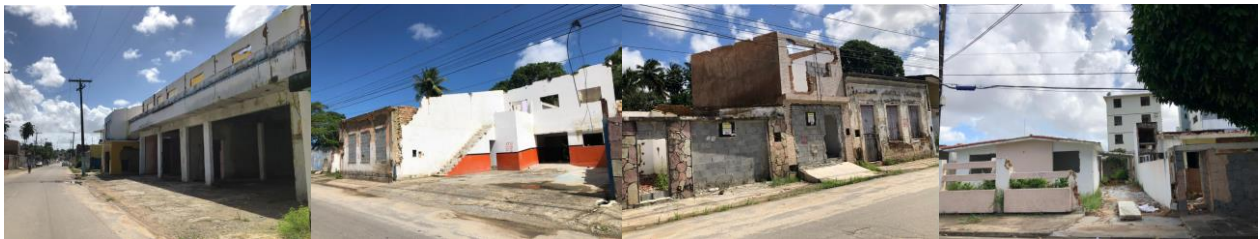
*Figures 24, 25, 26 and 27: Empty and dilapidated buildings.*

Even with the emptying of the area, represented by the sequence of images depicting abandonment and consequent silence (Figures 24, 25, 26 and 27), sound pressure levels did not drop significantly, with a decrease of up to 5dB(A). One of the reasons for not having a greater drop in SPL values is the presence of noise from mechanical equipment for restoring the area and motorcycles. The current local soundscape has a predominance of mechanical sounds, human sounds were silenced. The sounds of nature such as birds and leaves swaying in the wind were evidenced in areas near the lagoon.
